2008 Annual Inspection Report

BRADY CANAL HYDROLOGIC RESTORATION PROJECT (TE-28)

State Project Number TE-28
Priority Project List 3

May 1, 2008
Terrebonne Parish

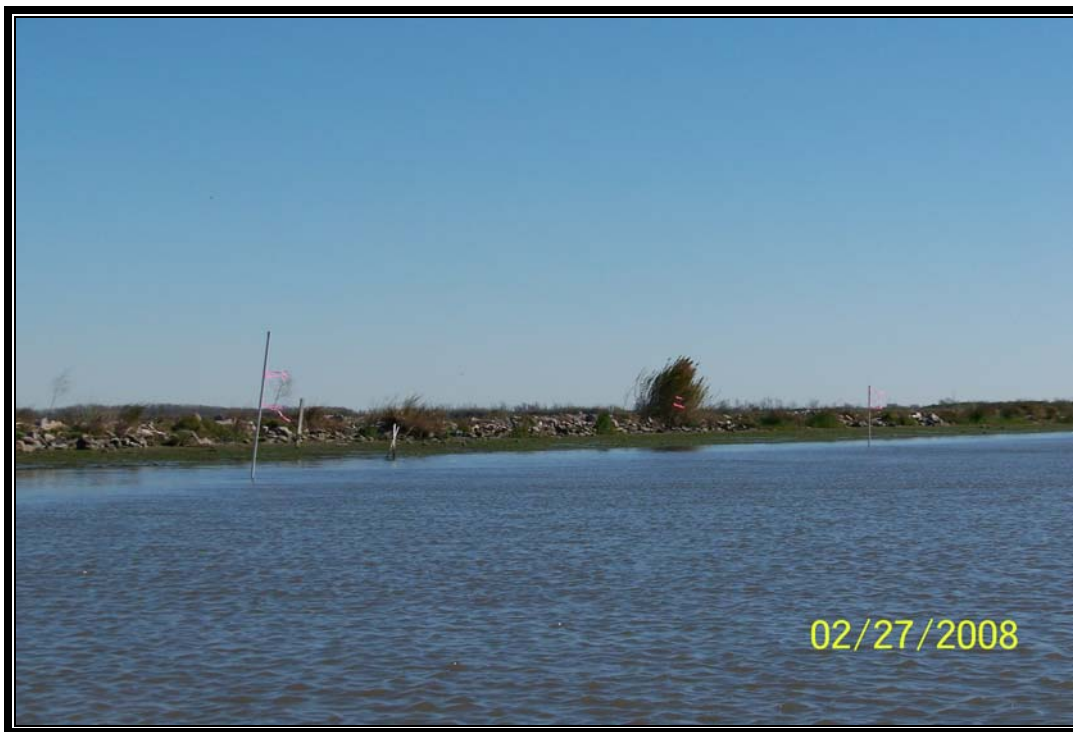
before and after Hurricanes Katrina and Rita, it is apparent that tidal surges during the storm had resulted in moderate displacement of the rock riprap. Considering the rock displacement that has taken place, the dike remains in good to fair condition with only isolated locations where settlement was visible. (Appendix B, Photos 21 - 25)

OCPR has received four (4) complaints from boaters in the area regarding boat motor damage as a result of an underwater obstruction below the water surface along the north bank of Bayou Decade between Turtle Bayou and Jug Lake. Each complaint indicated that as they were traveling Bayou Decade they struck an underwater obstruction, presumably large rocks below the water surface, causing damage to their outboard motors. At least one (1) of the boaters was able to provide an approximate location of the underwater obstruction. OCPR field personnel visited the site to investigate and found a small 2 feet diameter patch of rocks (2 or 3 large stones) below the water surface in the vicinity of the reported incident. This location was approximately 20 to 25 feet from the bank in 1 foot of water at the time of the investigation. A 50 linear feet section of Bayou Decade was marked with PVC pipes and ribbon to notify boaters of possible underwater obstruction. Each individual was asked to provide OCPR a written statement including dates, type of boat, travel speed, size of motor, description of damage and any other information and photos that would assist in assessing the damages. To date, only one individual has submitted the information requested by OCPR. This claim was reported to the risk management section of OCPR for further investigation. OCPR will continue to monitor this area until corrective action can be taken.

Photo No. 24 – rock dike revetment along north bank of Bayou Decade between Turtle Bayou and Jug Lake installed in 2003. Two (2) PVC markers installed to notify boaters of reported rocks below water surface in early 2008.

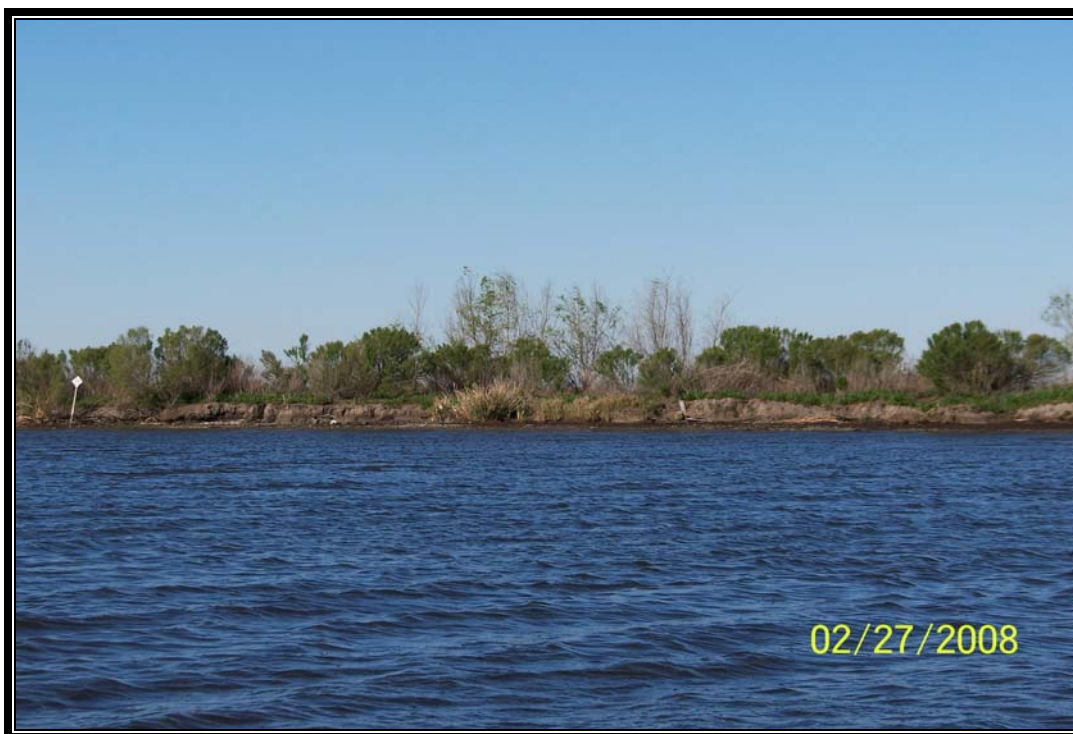
Breach Repair 5 & 6 – Breach 5 & 6 consisted of the refurbishment of a low area along Turtle Bayou from the mouth of Superior Canal 1500' southward, utilizing dredge material obtained from the canal bottom of Turtle Bayou. The entire length of the refurbished levee appeared to be in good condition with only minor cut banks which had developed along the toe of the embankment. (Appendix B, Photo 26)

Photo No. 26 – earthen embankment along Turtle Bayou (Breach Repair 5 and 6) near Superior Canal refurbished in 2003.

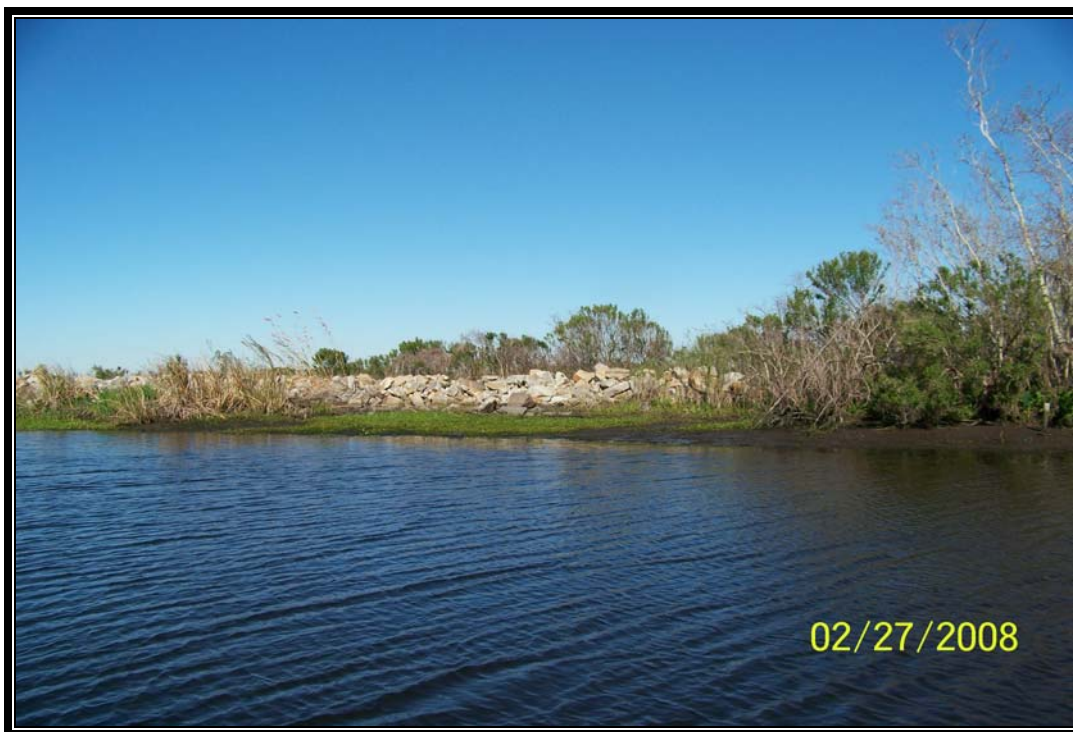
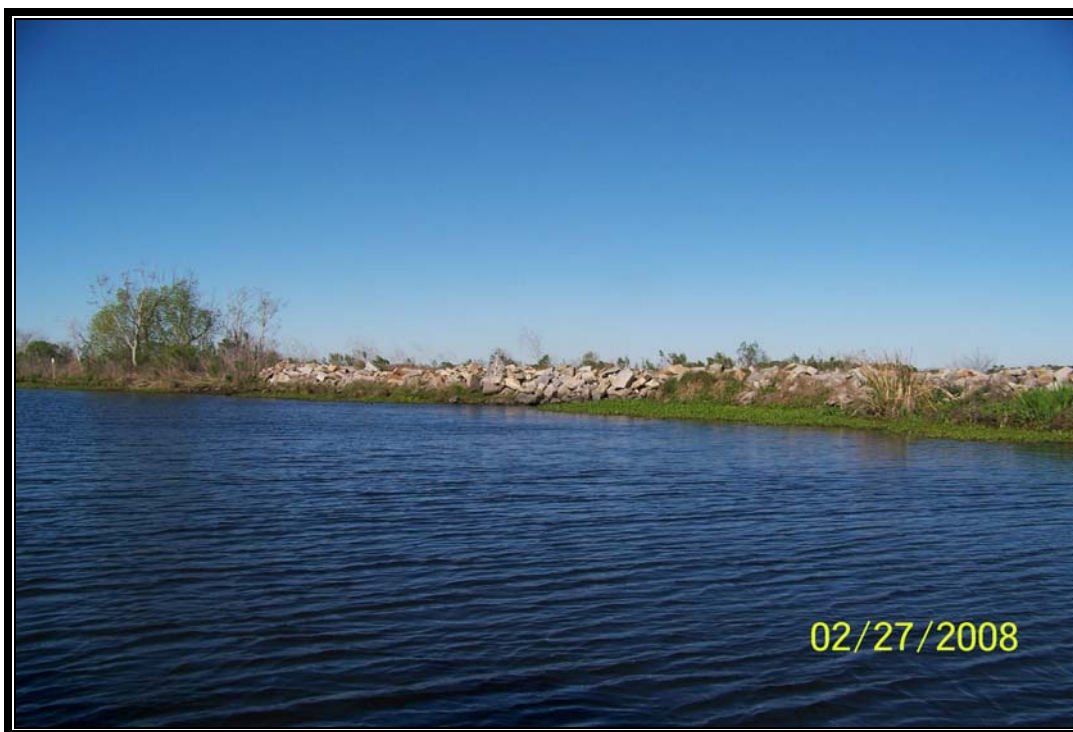
Breach Repair 7 – Breach 7 is located along an existing oilfield canal off of Superior Canal in the southeast section of the project area. Due to the depth of the opening in the earthen embankment, rock rip-rap was used to plug the breach and reinforce the adjacent bank line. The rock riprap breach closure appeared to be in very good condition with no visual signs of settlement or displacement. (Appendix B, Photos 27 - 28)

Photo No. 27 – rock dike plug (Breach Repair No.7) along oilfield canal off of Superior Canal to the west installed in 2003.

Photo No. 28 – rock dike plug closure (Breach Repair 7) along oilfield canal off of Superior Canal to the west completed in 2003.

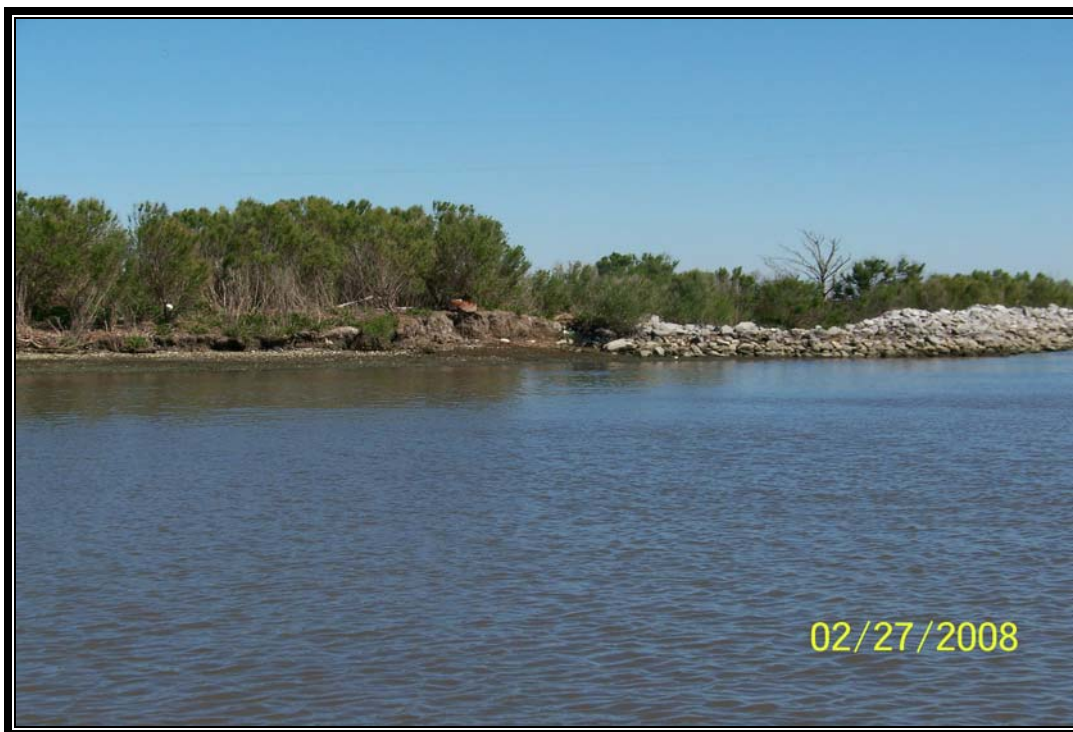
Photo No. 29 – view of moderate erosion near the end of rock revetment along Bayou Decade west of Structure 6.

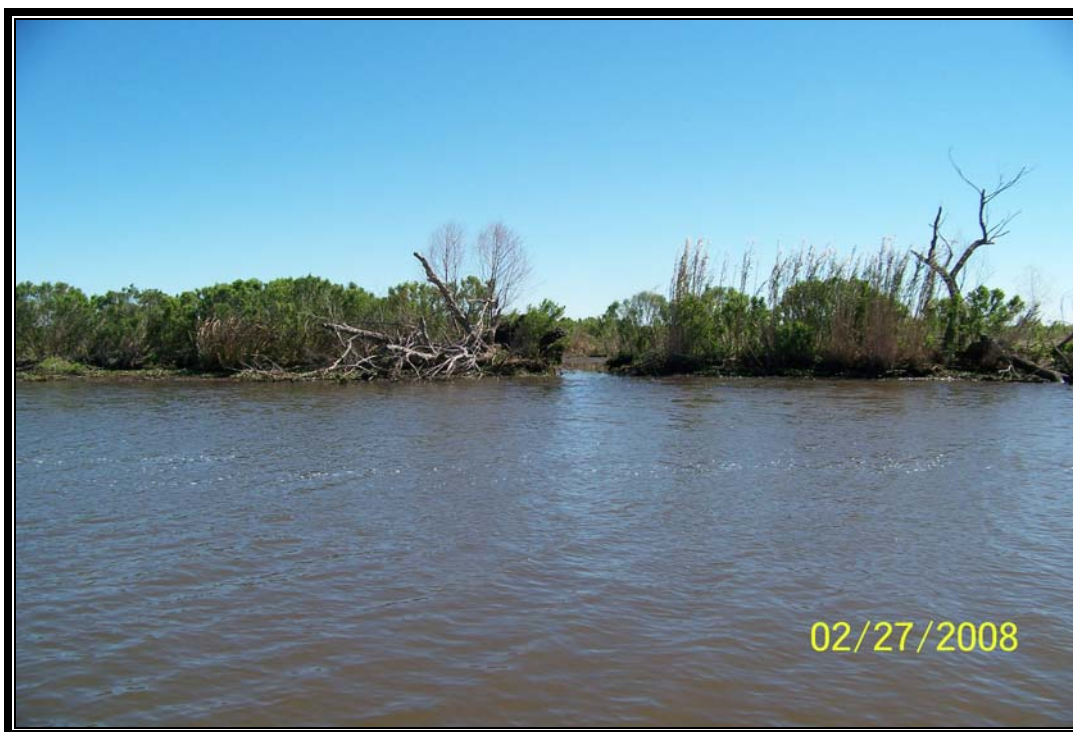
Photo No. 30 – breach location along the east bank of Little Carencro Bayou (Coordinates: N 29d 24' 12.4"; W 90d 59' 53.3" NAD83)

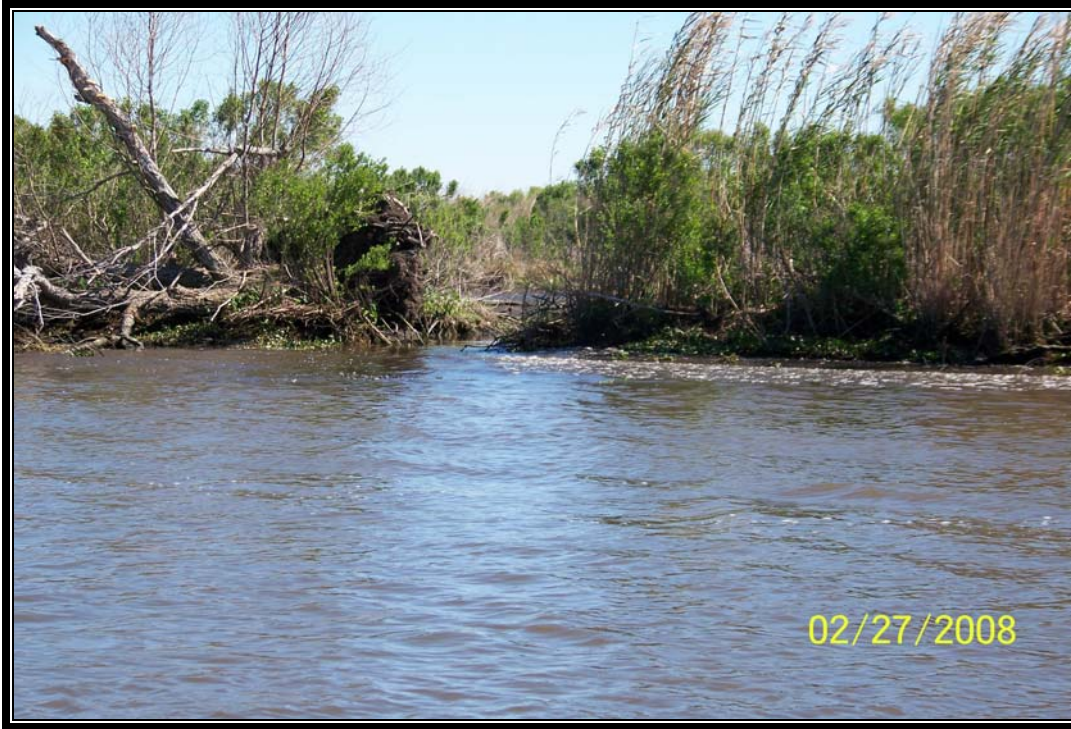
Photo No. 31 – breach location along the east bank of Little Carencro Bayou (Coordinates: N 29d 24' 12.4"; W 90d 59' 53.3" NAD 83)

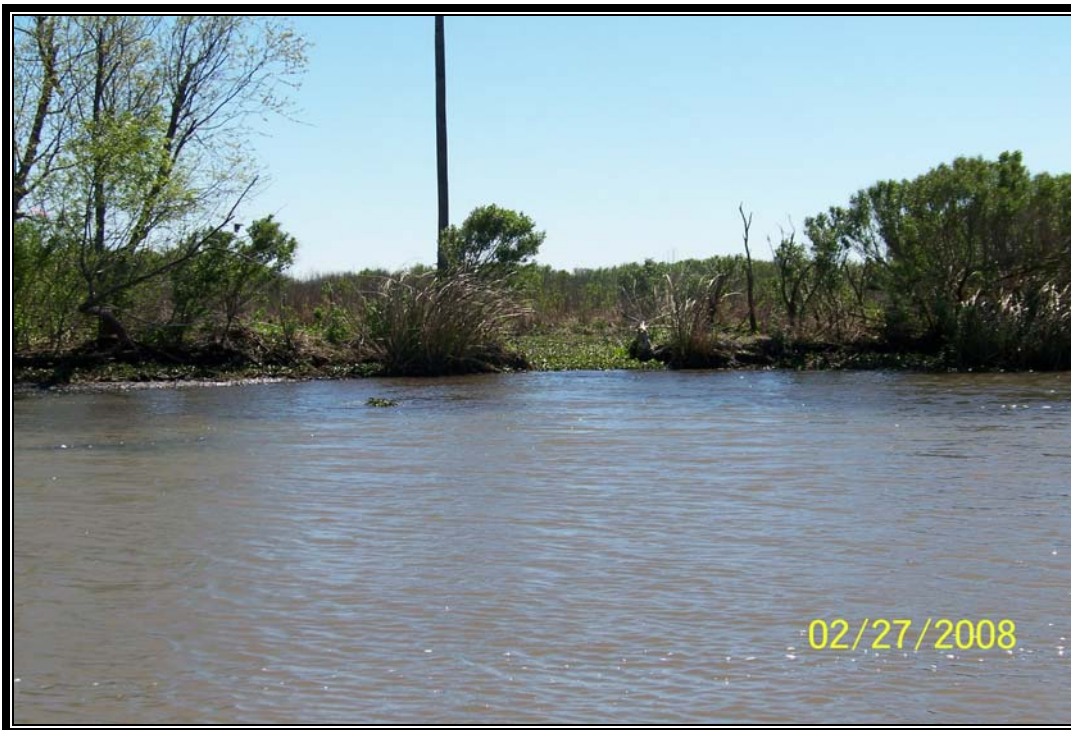
Photo No. 32 – breach location along the east bank of Little Carencro Bayou (Coordinates: N 29d 24' 26.9"; W 90d 59' 23.4" NAD 83)

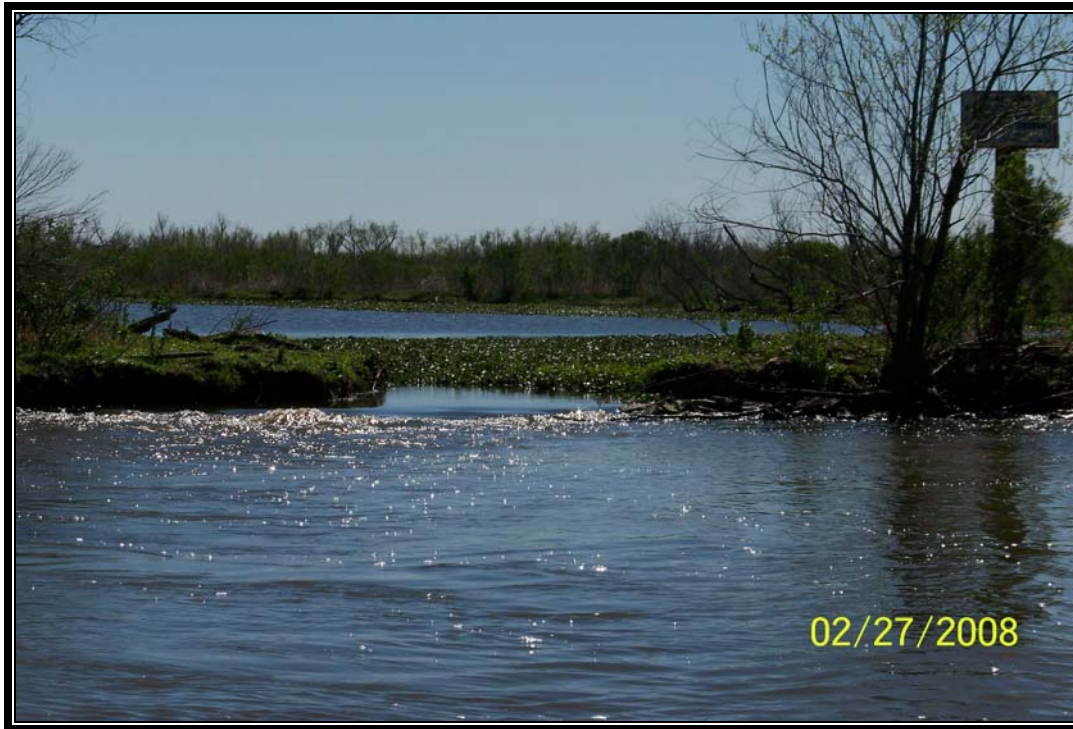
Photo No. 33 – Breach location along the southern bank of Brady Canal near the intersection of Brady Canal and Carencro Bayou within an existing pipeline right-of-way.

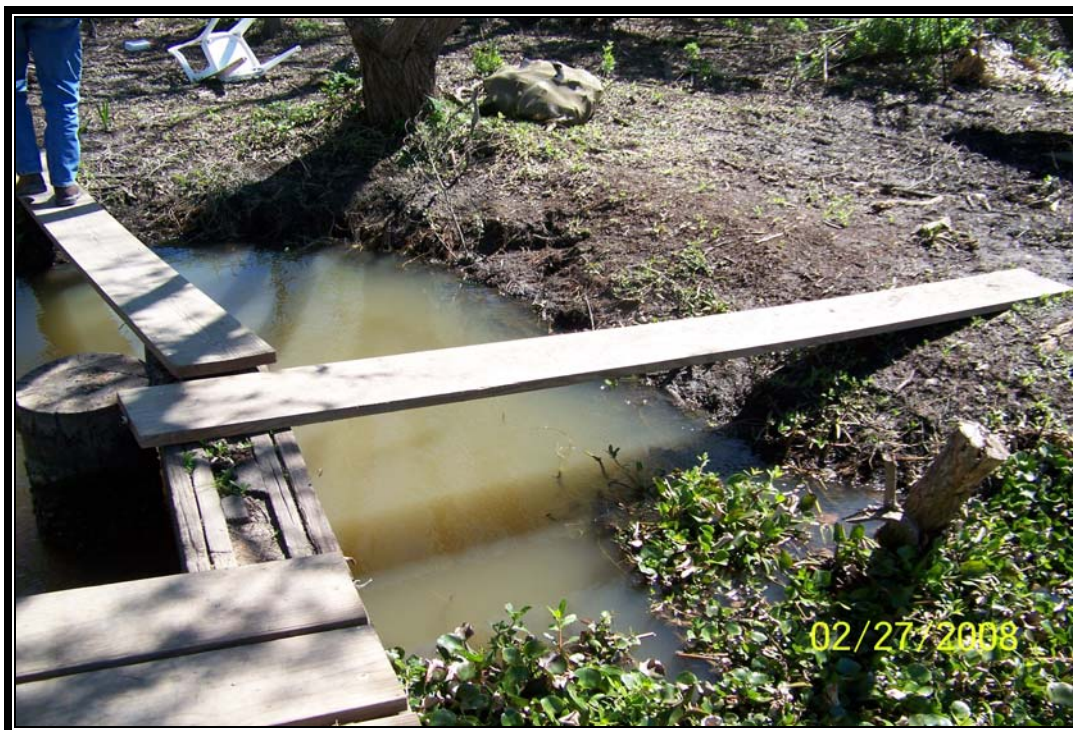
Photo No. 34 – Breach location along the south bank around an existing timber bulkhead at the intersection of Brady Canal and Carencro Bayou behind a house boat.

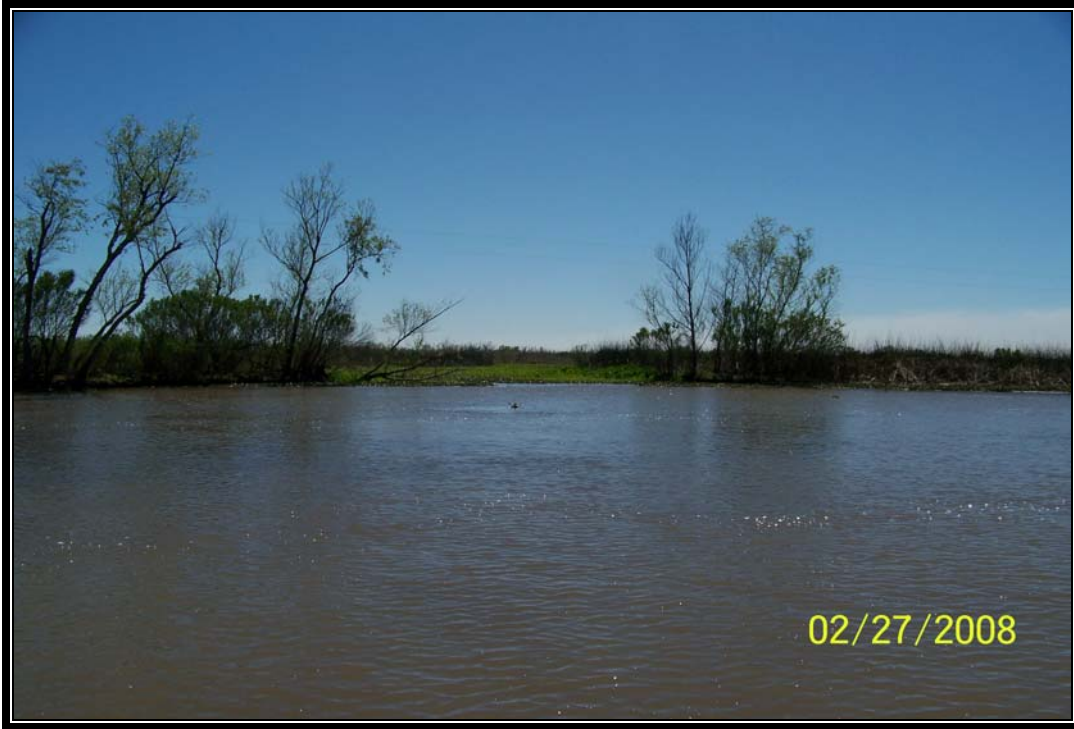
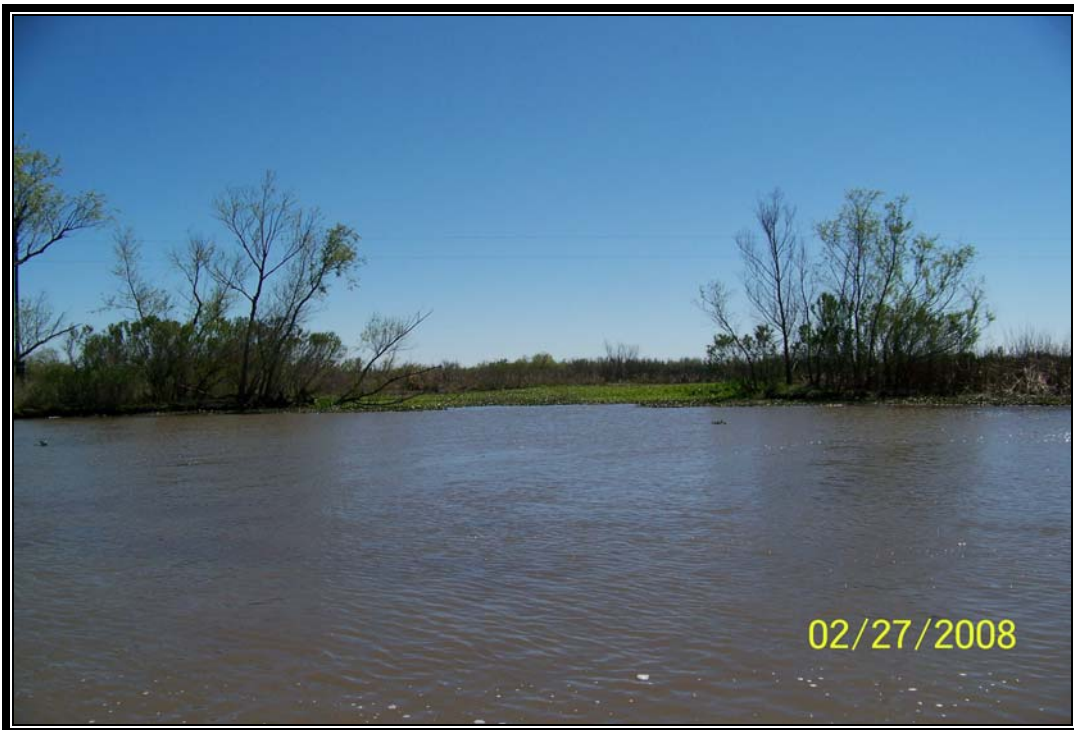
Photo No. 35 – Breach location located along the south bank of Brady Canal (Coordinates: N 29d 24' 26.9"; W 90d 58' 56.0" NAD 83)

Photo No. 36 – Breach location located along the south bank of Brady Canal (Coordinates: N 29d 24' 26.9"; W 90d 58' 56.0" NAD 83)
